Cold Mix Evaluation | Updated July 2009

Virginia Department of Transportation, Materials Division – Asphalt Program

Evaluation of Vialit Asphalt's Rephalt Cold Mix Patching Material (also known as Aquaphalt)

Report Origin: Todd M. Rorrer, Assistant Asphalt Program Manager

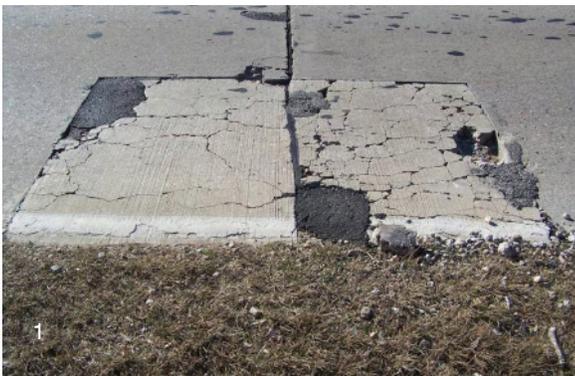
A deteriorated patch on US 60 West in New Kent County at Bottoms Bridge was selected for the evaluation site. This site would typically be repaired with hot mix asphalt (HMA), however the site was rapidly deteriorating and no HMA facilities were operational, therefore a 'permanent' cold patch solution was required.

Figure 1, Evaluation site on US Route 60 West at Bottoms Bridge.

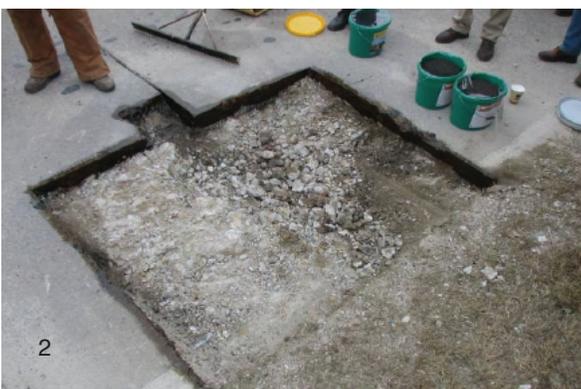
Figure 2

The existing distressed material was removed down to sound concrete. The leading half of the patch was found to be sound at a depth of approximately 5 to 6 inches (127 to 152.4 mm). The trailing half of the patch was deteriorated down to the subgrade in the center of the patch. The excavated patch was cleaned and blown free of loose debris, the deepest distressed portion was seated with a vibratory plate compactor.

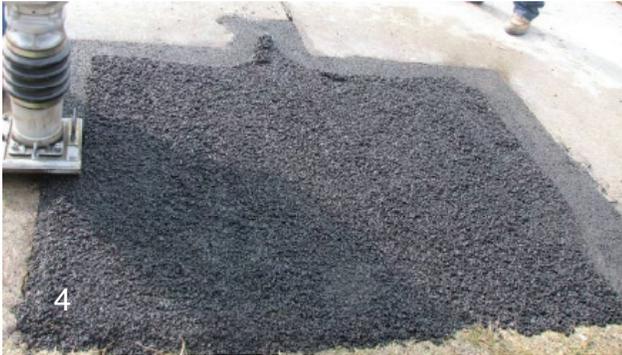
Figure 3, Two lifts 0/11mm mix were used as base and binder layers. The 'jumping jack' compactor was used for compaction on all layers lower than the final surface. Approximately 1 liter of water was added to each 25kg bucket before placement and an additional liter was "sprinkled" on the loose material before compaction.

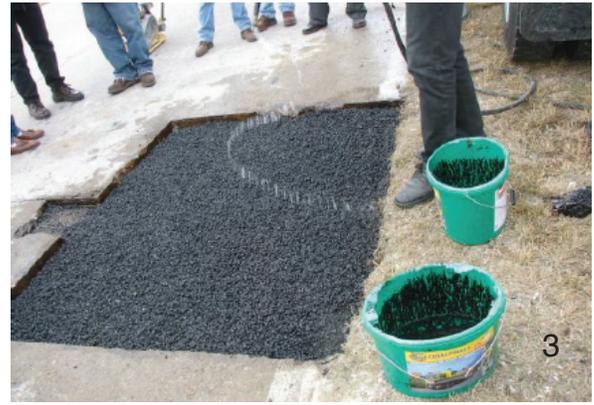
Figure 4. A final 0/8mm lift was placed for the final riding surface of the patch. Edges were pinched with the 'jumping jack' compactor.

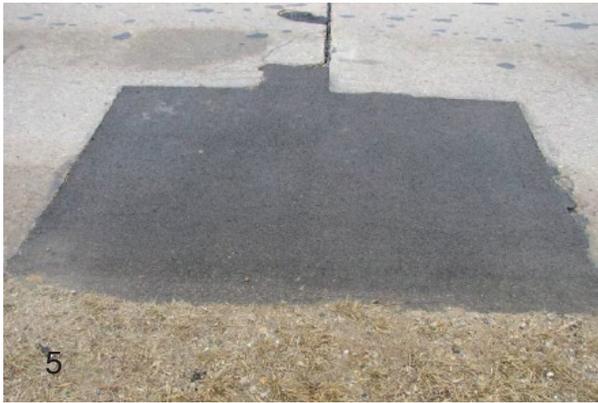
Figure 5, Evaluation site after one week of service.

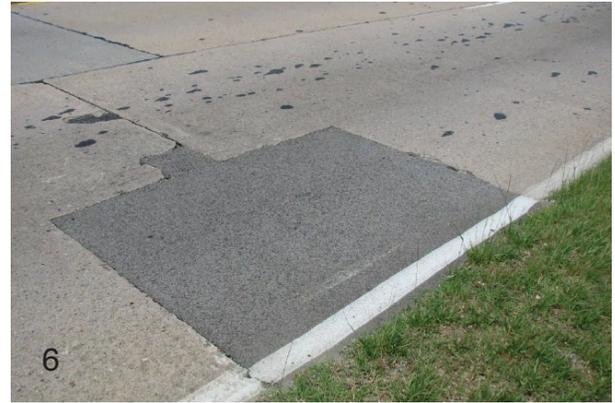
Figure 6, Evaluation site as of 06/26/08.

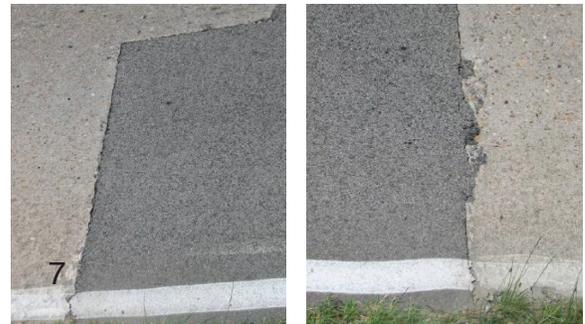
Figure 7. Material has maintained a uniform profile, very little to no pushing or shoving and no rutting. Tight joints have been maintained, material has not bled, or streaked away from the patch.

Five primary distress types were evaluated in the 1997 VTRC report used to generate VDOT's existing approved list: bleeding, rutting / dishing (further compaction under traffic), debonding, raveling and pushing & shoving. The Rephalt material did not exhibit any quantifiable distress in these five categories. To date the Rephalt cold mix material has met all expectations that the Virginia Department of Transportation has on cold mix patching materials.

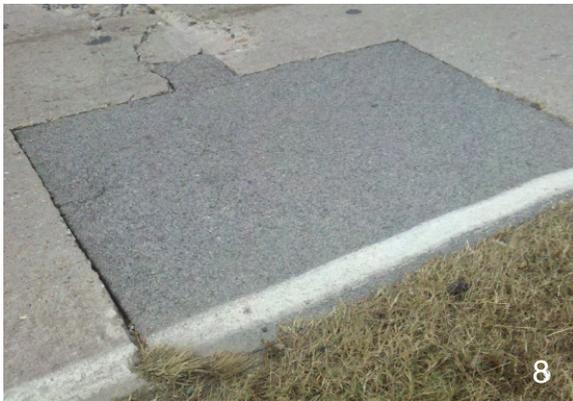
Figure 8, Four year follow-up photo, January 2012
